Hole # 12 Improvements

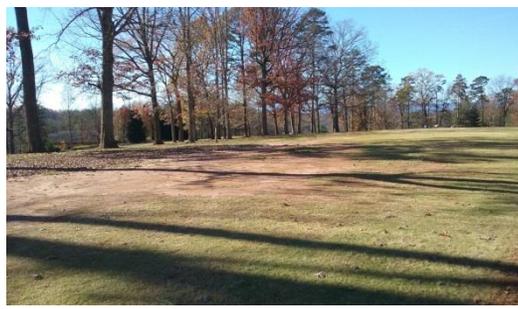
1. There is a large area in front of the tee box, along the left side of the fairway and in the landing area that is bare, mainly due to winter kill. Roughly 20 trees need to be removed from the area between 11 and 12 fairways to let more light in this area. Then this area could be hydro seeded with a better likelihood of surviving the winter. We would like to hydro seed an acre of Bermuda in this area.

Bare area in front of #12 tee boxes

1. Hydro seed fairway in front of tee boxes (1 acre)
\$3500
2. Tree Removal/trim limbs
\$11,500

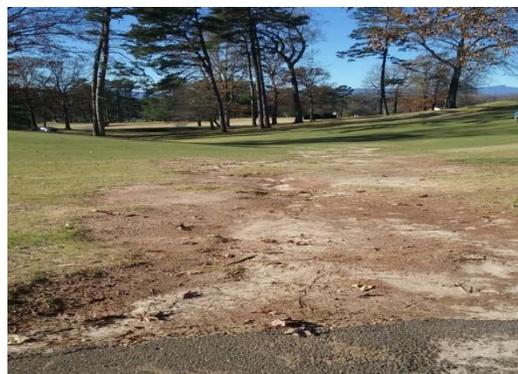
2. The area down at the bottom of hill has several issues. When it rains heavily, water runs down the valley in the area between 14 fairway and 12 eroding this area, washing away the cart path and depositing sand down in the fairway at the base of the hill. This area needs to have more trees (roughly 7) removed and trimmed to allow more sunlight in this area to promote grass growth. This area needs to be sodded, a berm needs to be formed and sodded to divert the water and a 75ft length of cart path needs to be repaired.

Erosion and Bare area of bottom of the hill #12 fairway

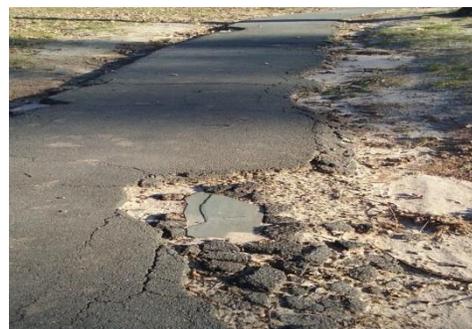
Cart path Damage on #12 near Valley

| 7. Cart path repair (75 ft) | \$1500 |
